**NESHAP RENOVATION / DEMOLITION INSPECTION OF  
ASBESTOS CONTAINING MATERIALS  
AND OTHER HAZARDOUS WASTE MATERIALS  
FOR THE PROPERTY KNOWN AS:**

318 W Larch Ave.  
Muskegon, MI 49441

January 15th, 2016

ETC Job #: 177227

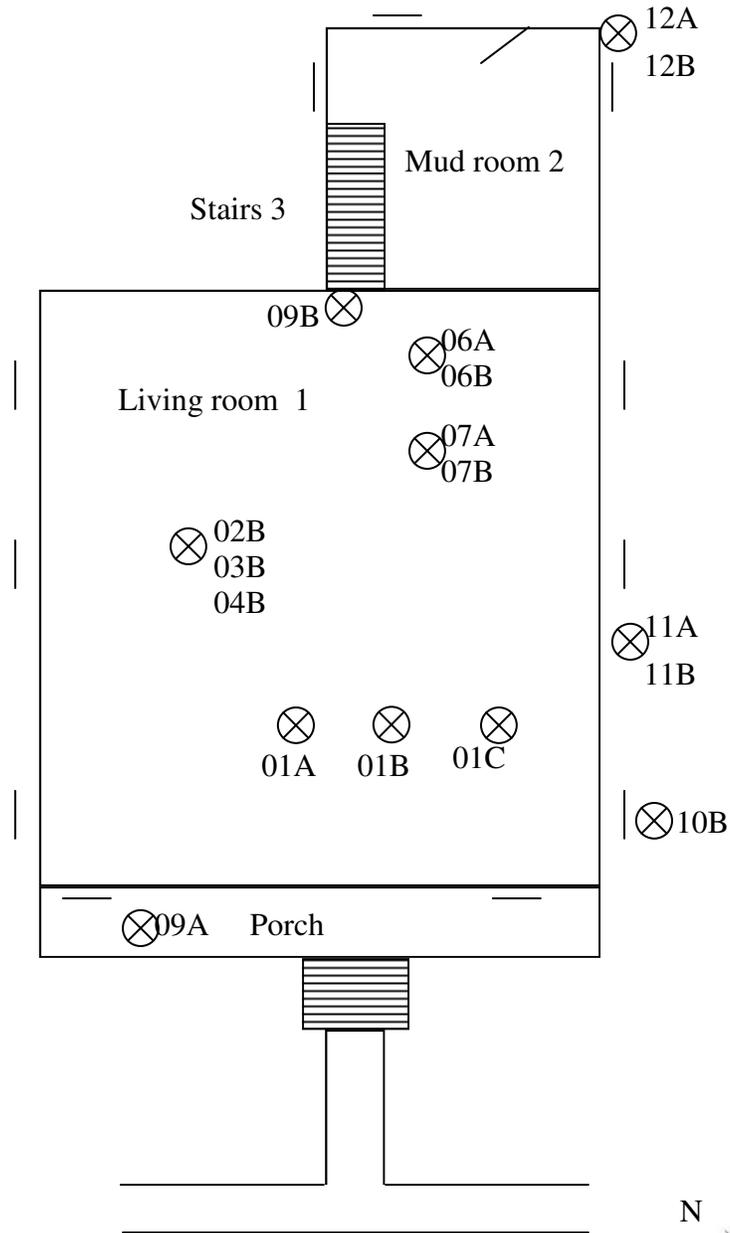
First Floor  
Ext. House 7

Please Note: This is a rough floor plan only. All items, (doorways, Windows, etc.) may not be included in this illustration. Also, room and component sizes are not drawn to scale.

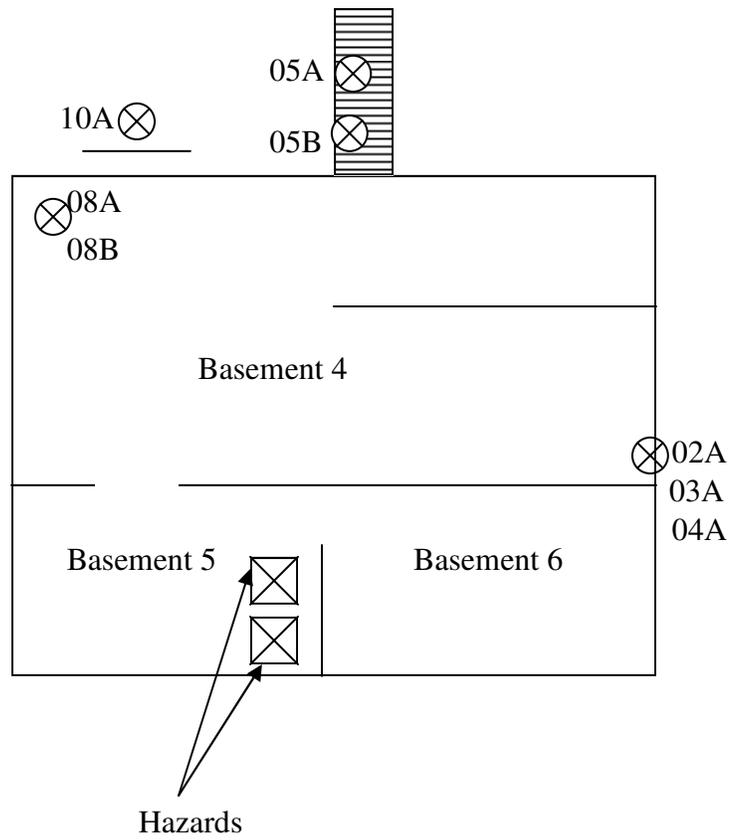
Basement

Please Note: This is a rough floor plan only. All items, (doorways, Windows, etc.) may not be included in this illustration. Also, room and component sizes are not drawn to scale.

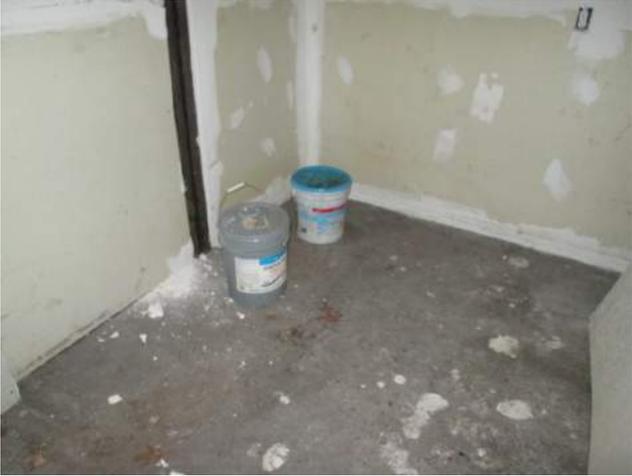
Material #	Material Description	Quantity	Location
1	Joint compound.	5 gallons	#5, SW Basement.
2	Paint Cans.	5 gallons	#5, SW Basement.

5 Gallon plaster/paint hazard's.

- Chart B – Is a list of other hazardous materials (above RCRA household quantity levels) that will require special handling and disposal by the contractor.
